# Fracture Surface of Polyester/Areca Nut Fiber Composite Under Impact and Tensile Loading

Sulaiman Thalib \*, Nurdin Ali, Husni, Frendy Imanuddin

Department of Mechanical and Industrial Engineering, Faculty of Engineering, Universitas Syiah Kuala, Jl.

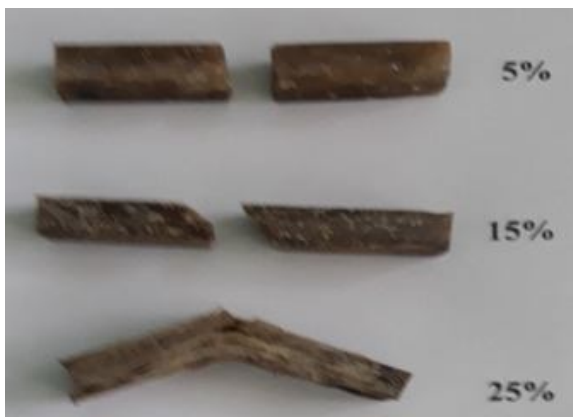
Figure 1: Specimen fracture due to Charpy impact test

The fracture of the specimen after impact testing can be seen in Figure 1. while the fracture by tensile testing is shown in Figure 2. Both of these images show macroscopic fractures in various compositions, respectively for specimens with different composition of polyester and areca nut fiber that is 5%, 15% and 25% by the weight of fibers in the composite. Specimens that experience Charpy impact loads (Figure 1) show that with the increasing fiber content, the characteristics of the material are more resilient. Fractures of specimens subjected to tensile loading for all compositions did not show differences in surface characteristics of fractures, and all exhibited as brittle characteristics as shown in Figure 1.

The Charpy impact test for specimens with 25% fiber content shows the characteristics of composite material specimens appear to be very resilient compared to other lower compositions. In Figure 1 with a fiber content of 25% the specimen did not break completely or was not separated in two parts after impact. This happens because cracks cannot propagate into the matrix, caused by the more dominant fiber content in the matrix thereby blocking crack propagation. In

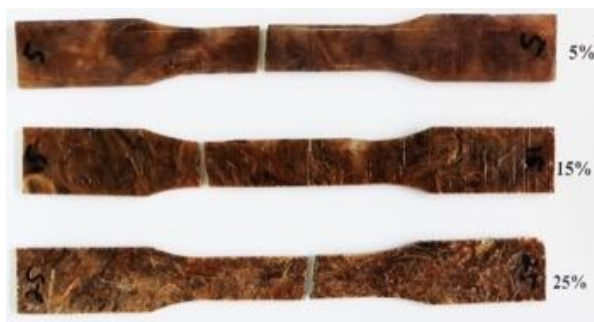
Figure 2: Specimen fracture by tensile test.

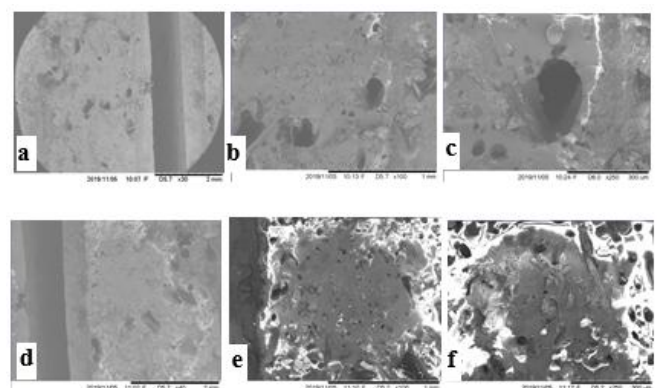
Figure 2 : Fracture surface under impact Charpy loading, specimen 15% weight fiber, (a), 30x (b) 100x (c) 250x, on the other side (d) 40x, (e) 100x and (f) 250x

Figures 3a to 3c of micrograph photo results using SEM at 30x, 100x, and 250x magnification respectively, This image shows a broken surface on one side. Figures 3d to 3f show broken surfaces on the other side. On Charpy impact loading with a composition of 15% by weight of fiber shows a more obvious surface fracture mechanism compared to other compositions. If observed with a greater magnification of 250X, the fracture surface shows unequal conditions for both sides, on one side it shows a smooth surface condition and also shows the void, surface conditions on the other side, show more rough conditions. Both sides of the fracture do not indicate a gap between the fiber and the matrix. Because it shows a good adhesion between the fiber and the matrix while the void is formed during processing due to trapped air.

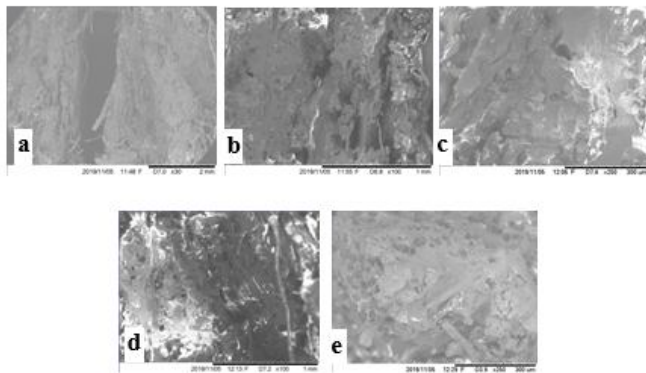
**Figure 3:** Fracture surface under impact Charpy loading, specimen of 25% weight fiber, (a), 30x (b) 100x (c) 300x, on the other side (d) 100x and (e) 300x

To clearly see the fracture surface of a composite material with a 25% fiber composition can be observed in Figures 4a to 4e, from this figure, it can be seen the fracture condition where the fracture surface does not show any gaps between the fiber and polyester matrix, this shows that most of the fracture area appears a good adhesive between the two materials. When observed from the side of the fiber on the fracture surface in the image it can also be seen that the fiber can be cut off, partially pulled so as to see the condition of the form of the stringy surface. When compared with 15% fiber composition composites which show smoother fracture surfaces, then composites with greater fiber content become more ductile.

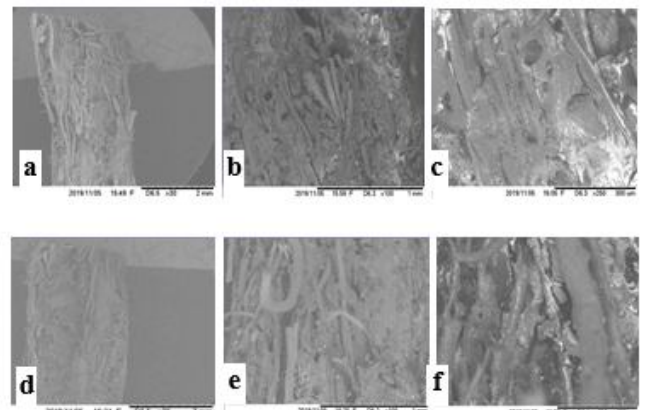
**Figure 5:** Fracture surface under tensile loading, specimen 25% weight fiber, both of part (a) 30x, (b) 100x and (c) 300x, other side (d) 30x, (e) 100x, (f) 300x

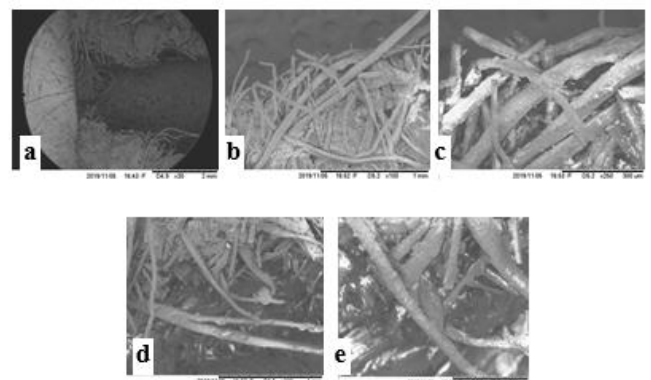
**Figure 6:** Fracture surface under tensile loading. specimen 25% weight fiber, view on transversal direct, (a) both of part fracture 30x, (b) 100x, (c) 250x, other side (d) 100x, (e) 300x

The surface fracture characteristics on the tensile loading shows a difference with the impact surface fracture characteristics. On tensile loading the fracture surface shows more stringy because the tip of the fiber is pulled out of the matrix as shown in Figure 6. In the picture can also be seen fracture surface also shows the fibers in the transverse direction of the specimen, this shows that the arrangement of fibers in the composite is random. If viewed from the aspect of loading speed, tensile testing is carried out using a pull speed of 2 mm/minute, with this velocity the fracture opening also occurs slower than the fracture opening at the impact loading. As is known the speed of loading the impact test is much faster than the speed of loading the tensile test. Testing conditions with slow tensile speeds can cause fibers to be pulled out of the matrix, and some of the matrices on the fracture surface are destroyed. The fracture surfaces in the same specimen can be seen in the transverse direction as Figure 7a to 7c. Consequence of the fiber being torn out and the matrix destroyed, the fracture surface is very rough and many ends of the fibers protrude out into the form of fibers.
